Pavement Rehabilitation Manual

VOLUME 1: PAVEMENT EVALUATION

**MATERIALS BUREAU
NEW YORK STATE DEPARTMENT OF TRANSPORTATION**
Mario M. Cuomo, Governor/Franklin E. White, Commissioner

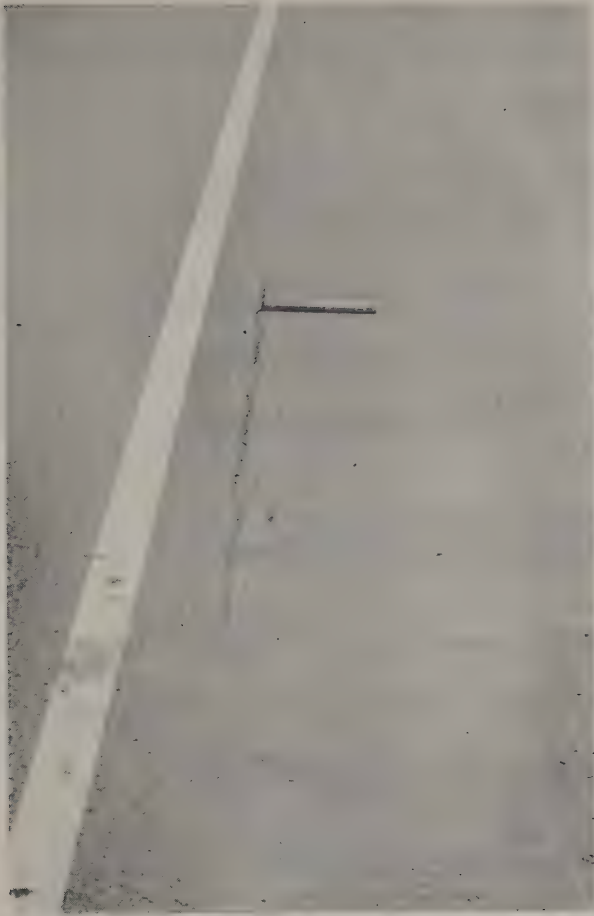
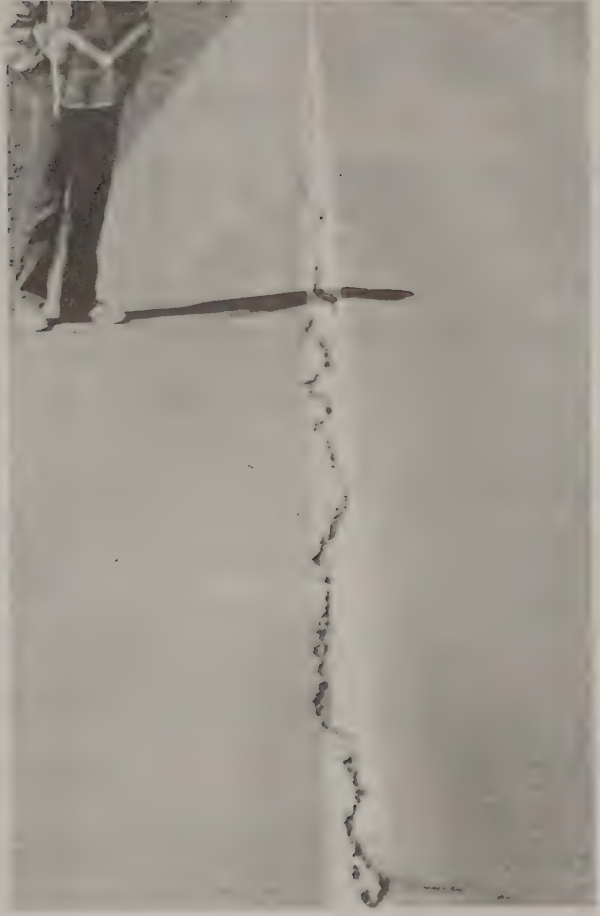
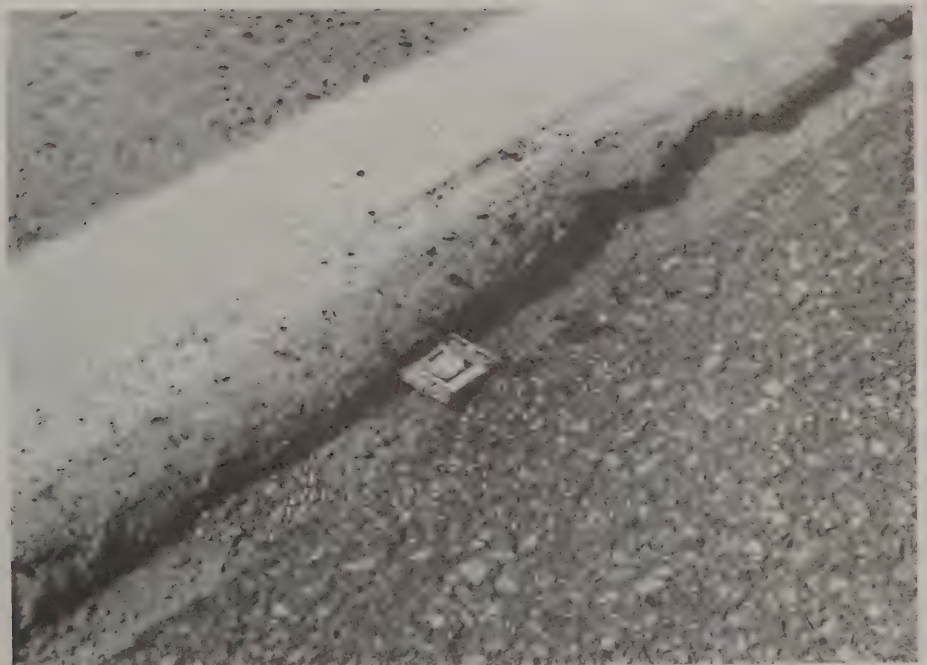
Figure D2 - Lane/Shoulder Separation

Low (AC Pavement)

High (AC Pavement)

High
(PCC Pavement)

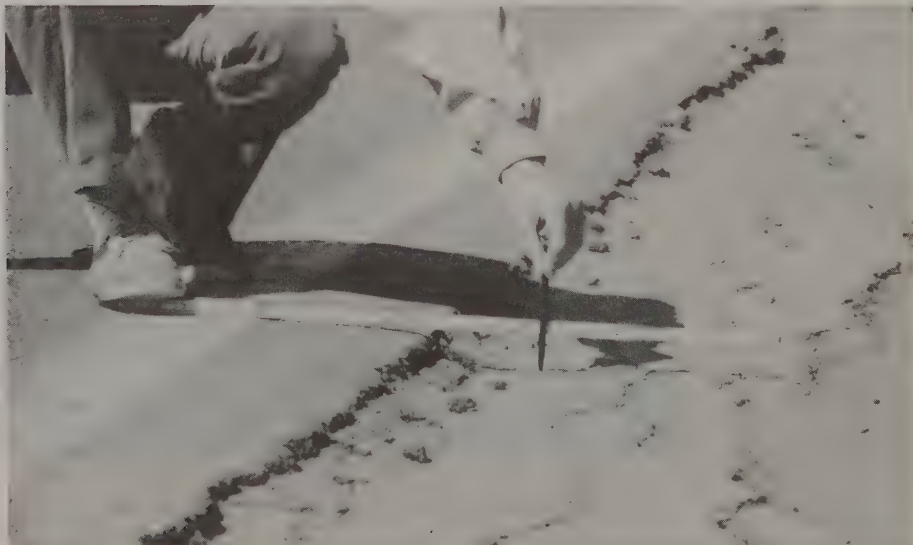
Figure D3

Lane/Shoulder Dropoff
